Portage Creek Sediment Remediation Project Kalamazoo, Michigan

Pre-Sediment Removal Structure Feature Assessment Removal Areas SA5-Axtell, SA5-D and SA5-C

F&V Project Number: 809930
May, 2012

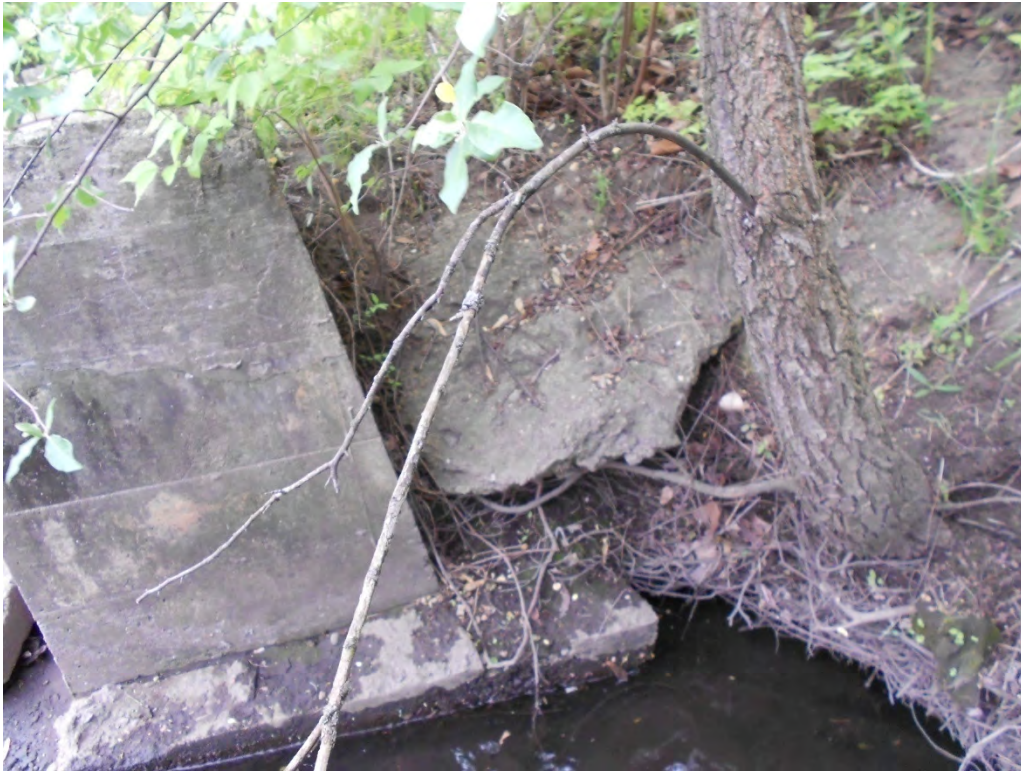
Severe erosion behind the northwest abutment

- Because the structure has been abandoned, it can likely be removed. However, it is recommended that the City of Kalamazoo be consulted to verify as it may be feasible to salvage the abutments for a future crossing at this location.

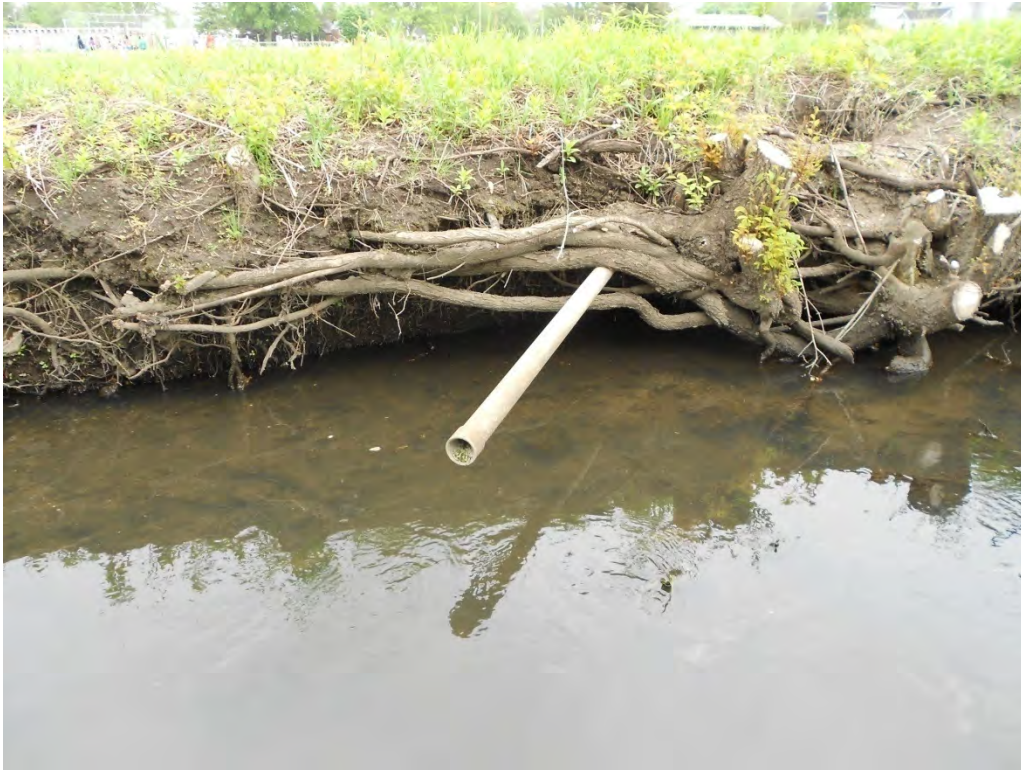
- Severe bank erosion appears to have caused the conduit's extension into the channel. The bank is severely undercut in the area.
- The conduit is plugged with debris and appears to be abandoned.

View of the structure from the channel with severe root growth and bank undercutting

- Because the structure appears to be abandoned, it can likely be cut off and plugged at the bank to allow for sediment removal.

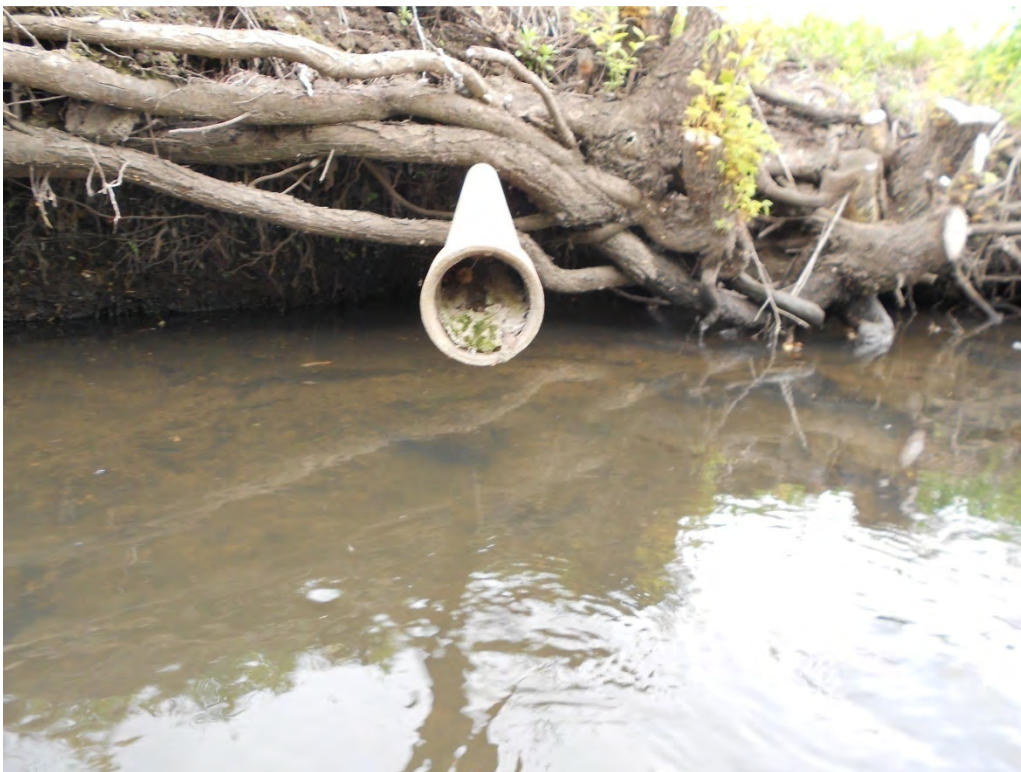
Close-up of the end of the conduit plugged with debris

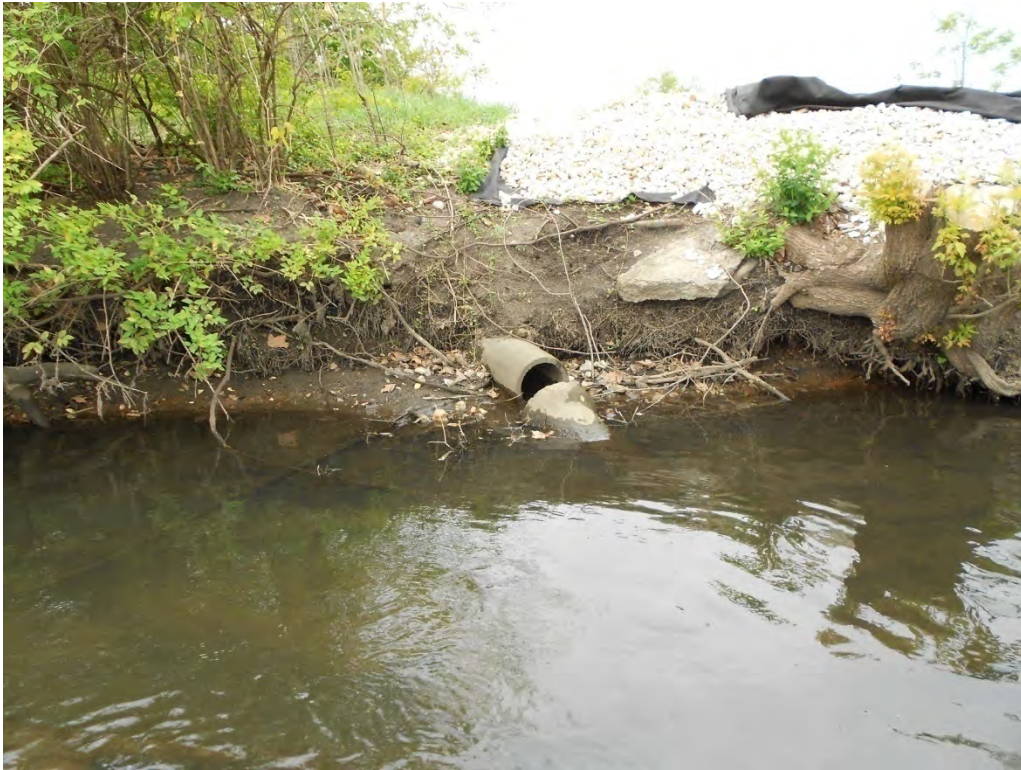
- The end section of pipe has failed from severe bank erosion and the second section is exposed ~18-24".

View of the structure from the channel

- Remove the failed end section and install an isolation cofferdam with approximately 2' clearance. Because the outlet appears to be from previous development and not active, it may be possible to eliminate the isolation cofferdam and use caution to avoid undermining the structure.

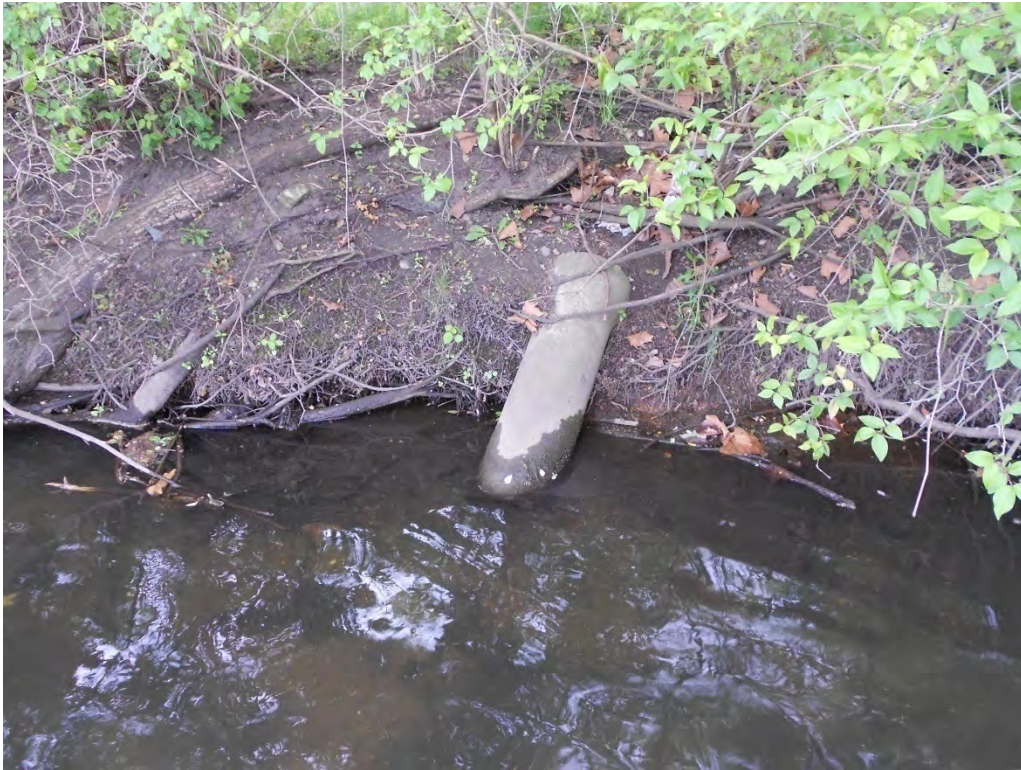
- The end section of pipe has failed from severe bank erosion.
- The outlet does not appear to be active.

View of the structure from the channel

- Remove the failed end section. Because the outlet does not appear to be active, an isolation cofferdam is likely not required. The outlet is located far enough above the waterline in the bank that undermining is not a significant concern.

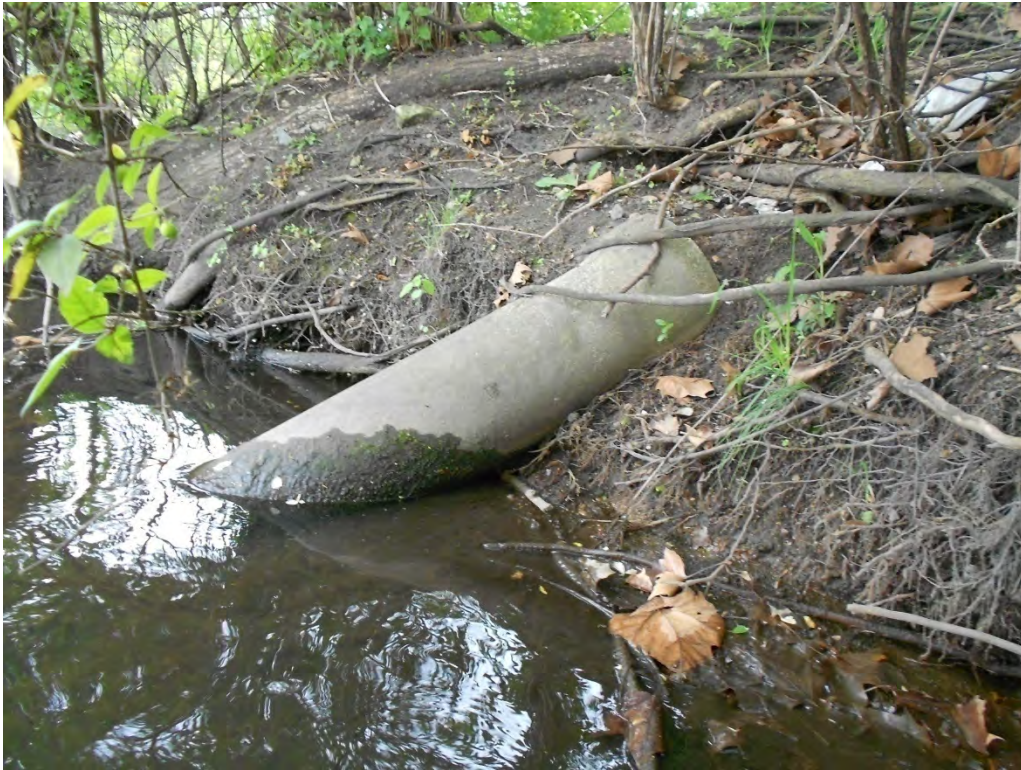
View of the structure from the downstream channel

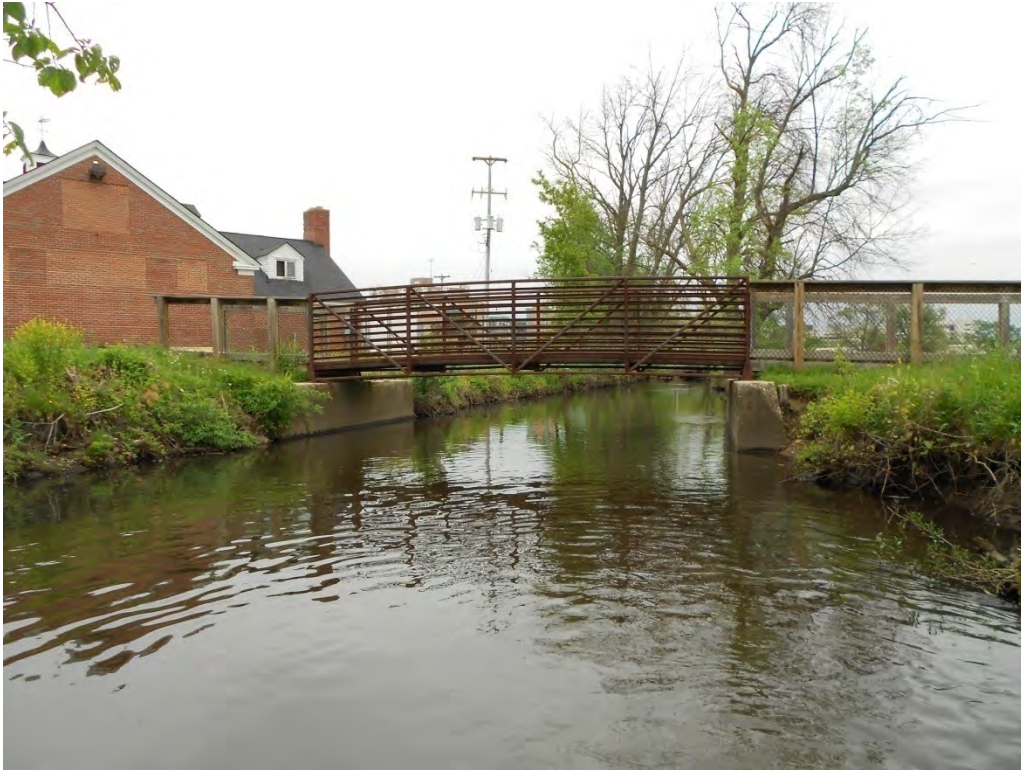
- Moderate bank erosion was noted around the southeast abutment. Roots from large stumps are holding the west banks.
- The top corners of the abutments are spalled throughout.
- The channel bottom is approximately 5' below the bottom chord of the truss. Logs and trash were noted in the northeast channel.
- The truss is weathering steel and has developed its patina, but minor pitting was noted.
- The timber decking has moderate weathering and splitting of planks throughout.

Elevation view of the structure from the upstream channel

- Construction records are not available for this structure, however it is suspected that the abutments are supported on spread footings several feet below the current channel bottom. We understand that the steel truss is to be temporarily removed to accommodate sediment removal. In this case, a cofferdam is recommended around each abutment to protect them from undermining. Because of the suspected depth of footing, it may be possible to begin sediment removal without cofferdams and install them only if the sediment removal is required below the bottom of footing elevation.
- If the truss is not removed, a simple isolation cofferdam across the channel is recommended upstream and downstream a minimum of 2' clear of the abutments.

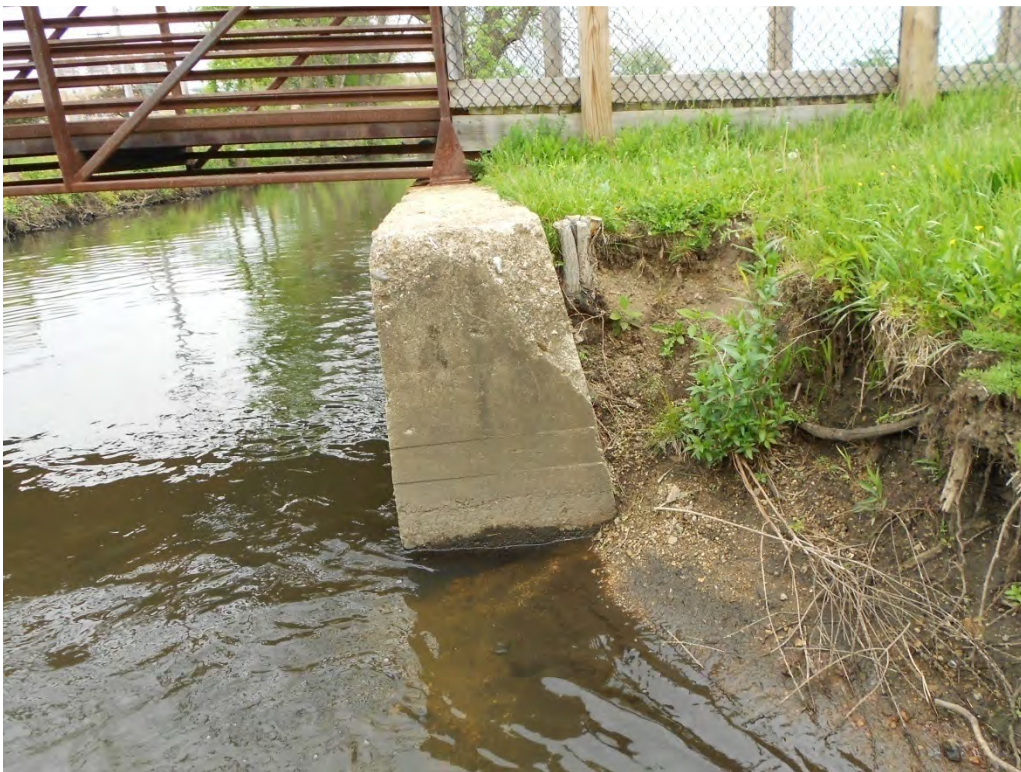
Bank erosion in the southeast

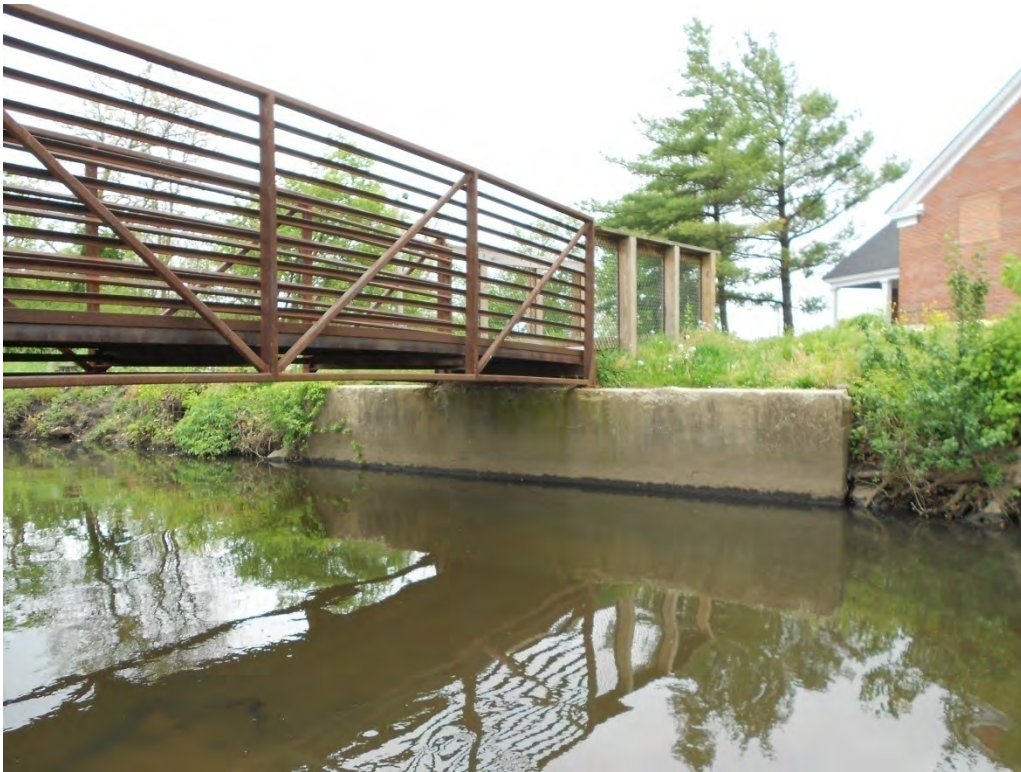
Overall view of the west abutment

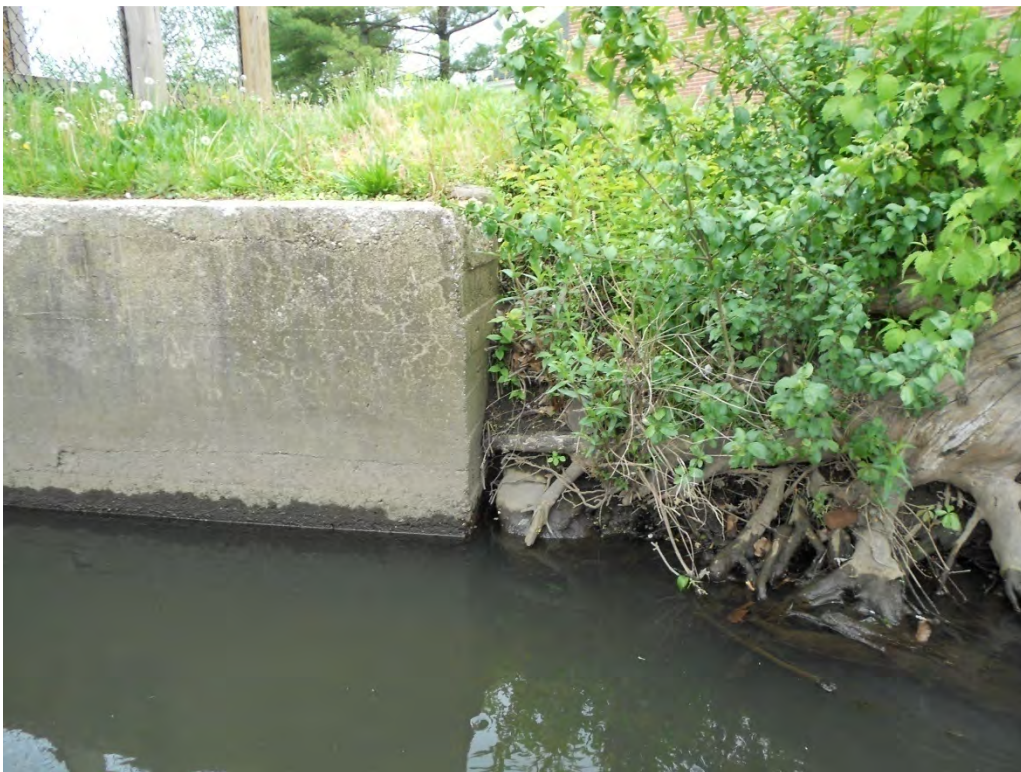
Northwest bank stabilized by roots

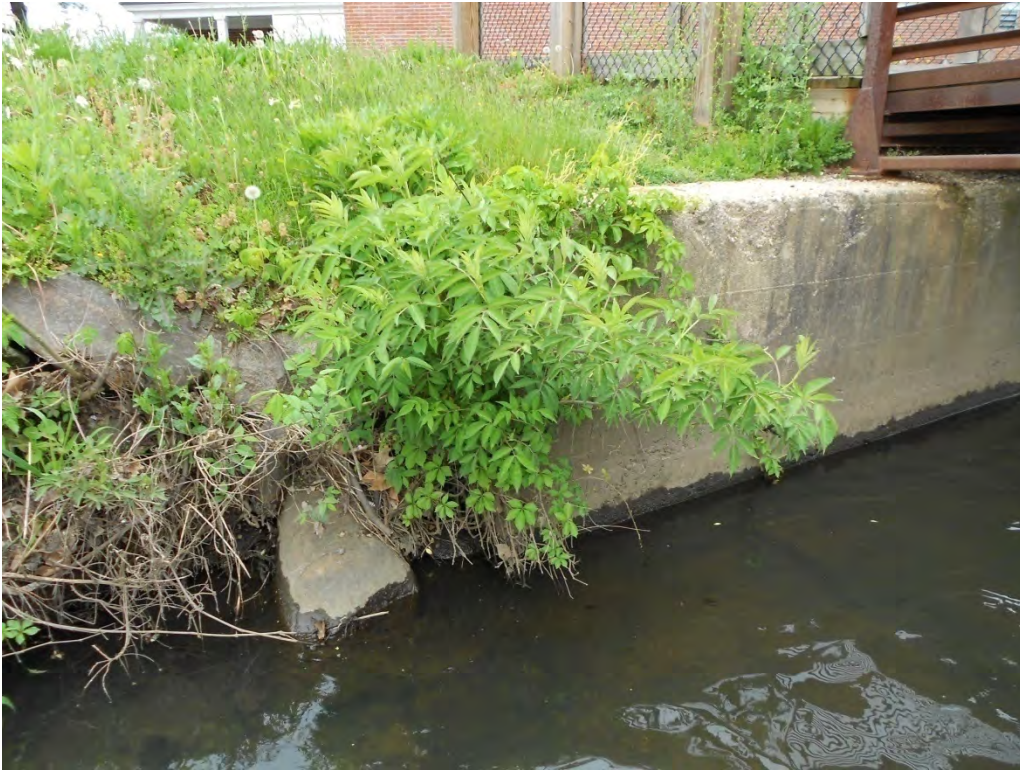
Southwest bank stabilized by roots

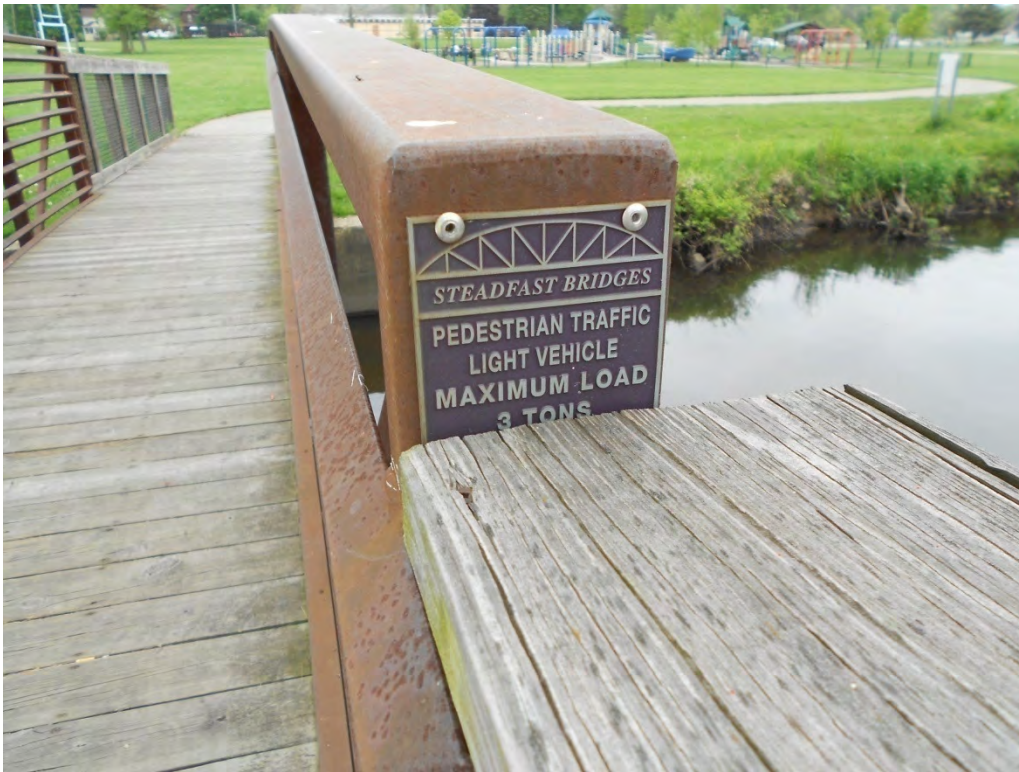
Bridge plate obscured by approach railing

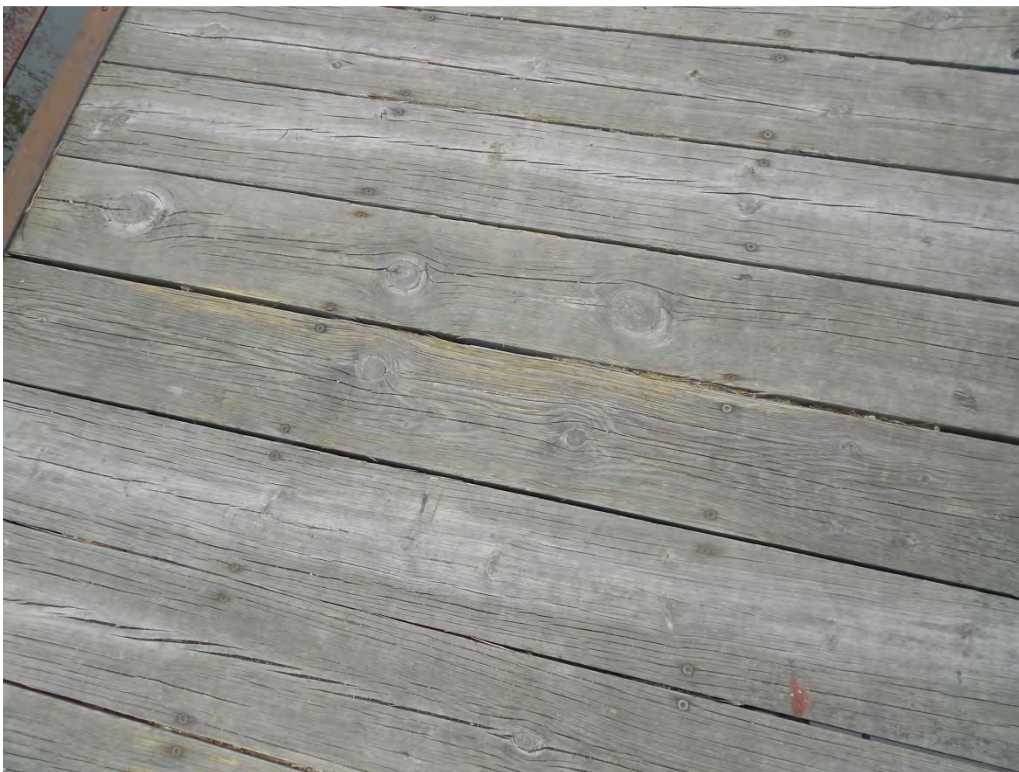
Weathering and splitting of timber deck planks

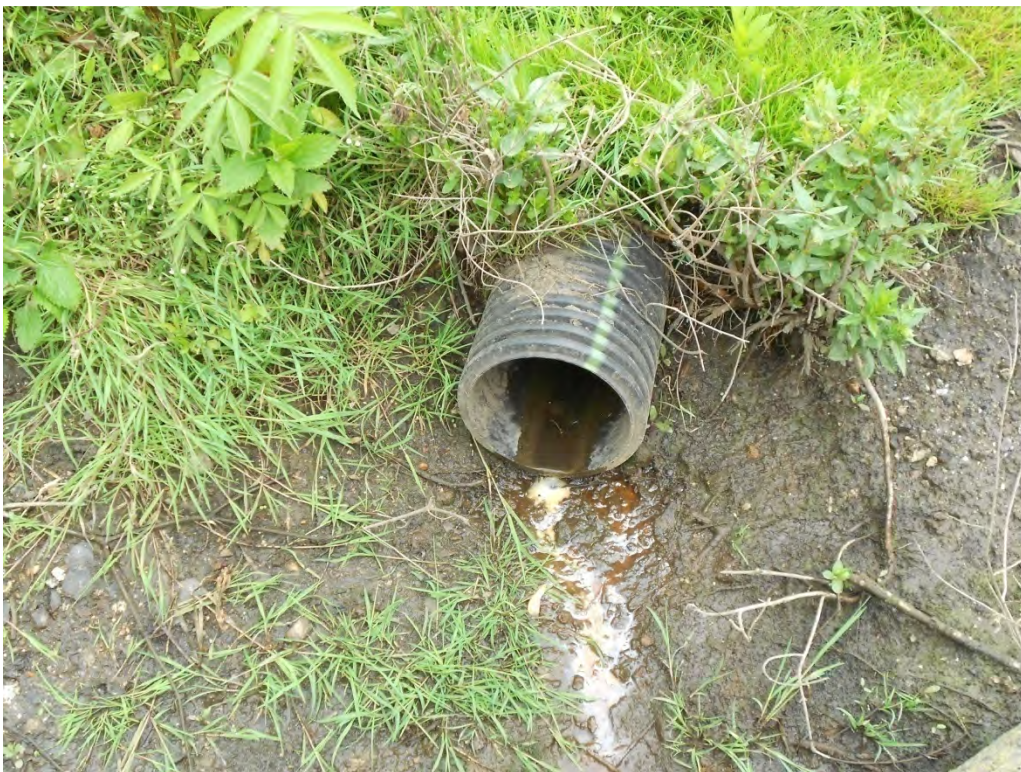
- Moderate bank erosion has exposed ~12-18" of the pipe, however, the pipe is set back approximately 2' from the water's edge in an area where the bank is low.
- The pipe appears to be in good condition with no significant deterioration noted.
- The outlet is slightly undermined.

Small flow of water from outlet

- Because the structure is set back from the water's edge, further undermining is not a significant concern. However, undermining should be repaired if it does occur.
- At the time of evaluation, the outlet had a small flow of water and an isolation cofferdam is recommended for dewatering.

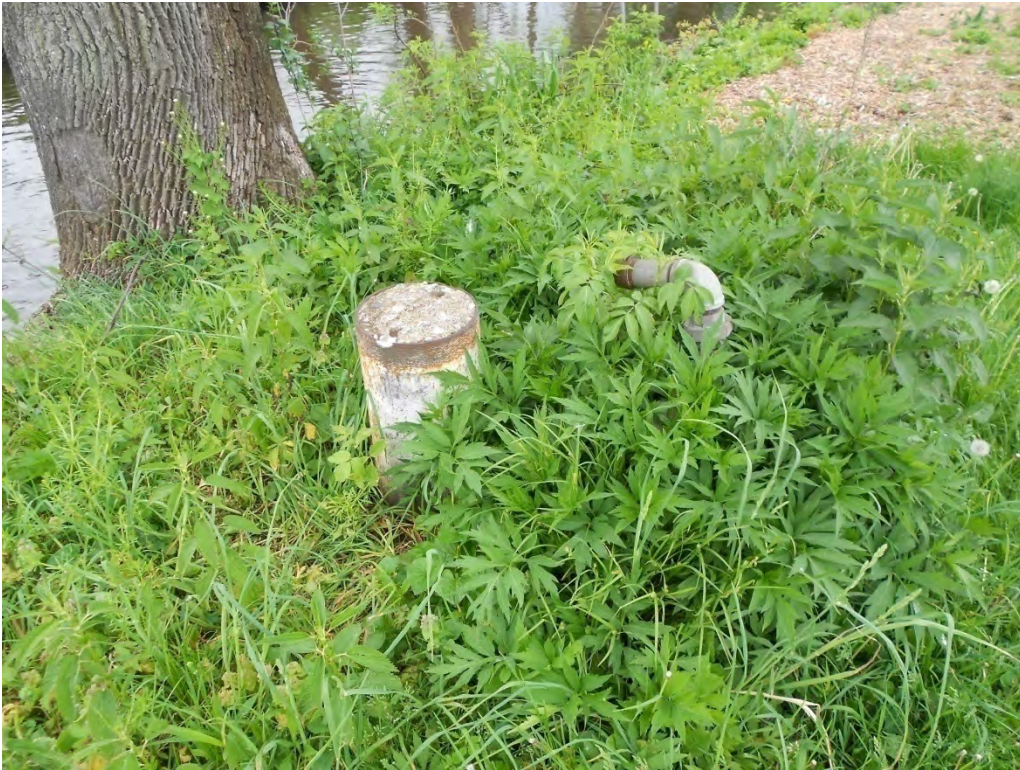
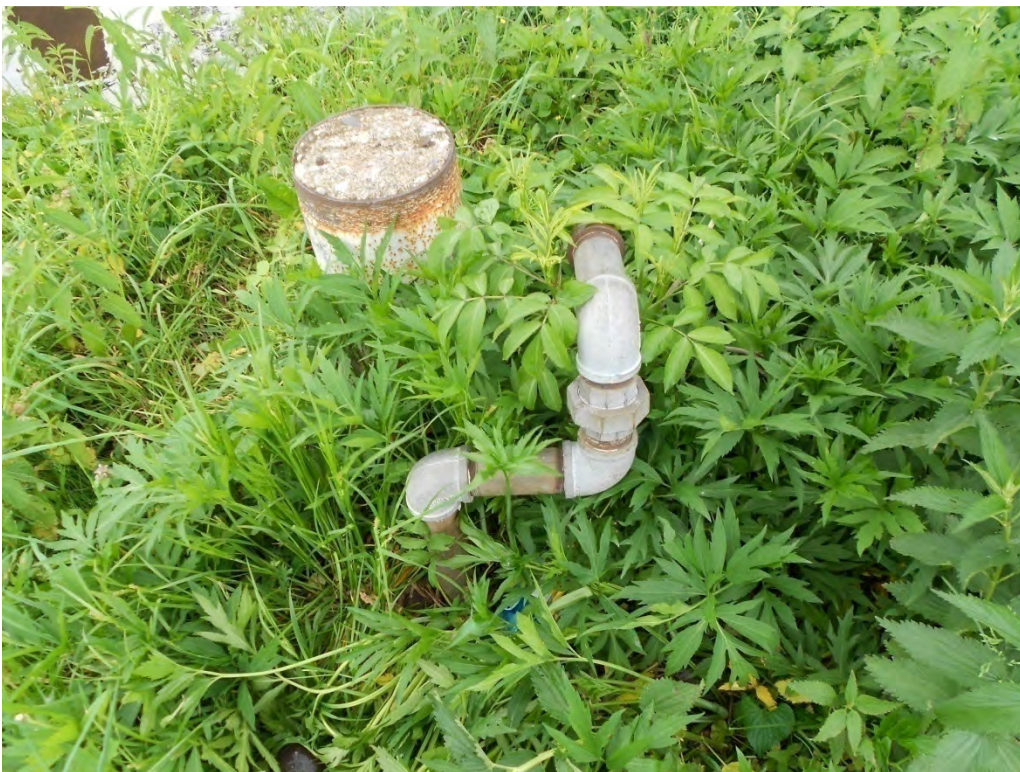
- Both bollards have minor surface corrosion and are overgrown with vegetation.
- The east bollard is set back approximately 4' from the water's edge behind a large tree. The west is located approximately 1' from the water's edge.

East bollard and suspected abandoned gas main

- The bollards and conduit should be protected from damage during excavation operations by installing construction fencing or other means to make operators and drivers aware of their location.
- The west bollard can likely be removed if it conflicts with excavation operations, however the east one should be avoided to prevent impacting the suspected abandoned gas main.

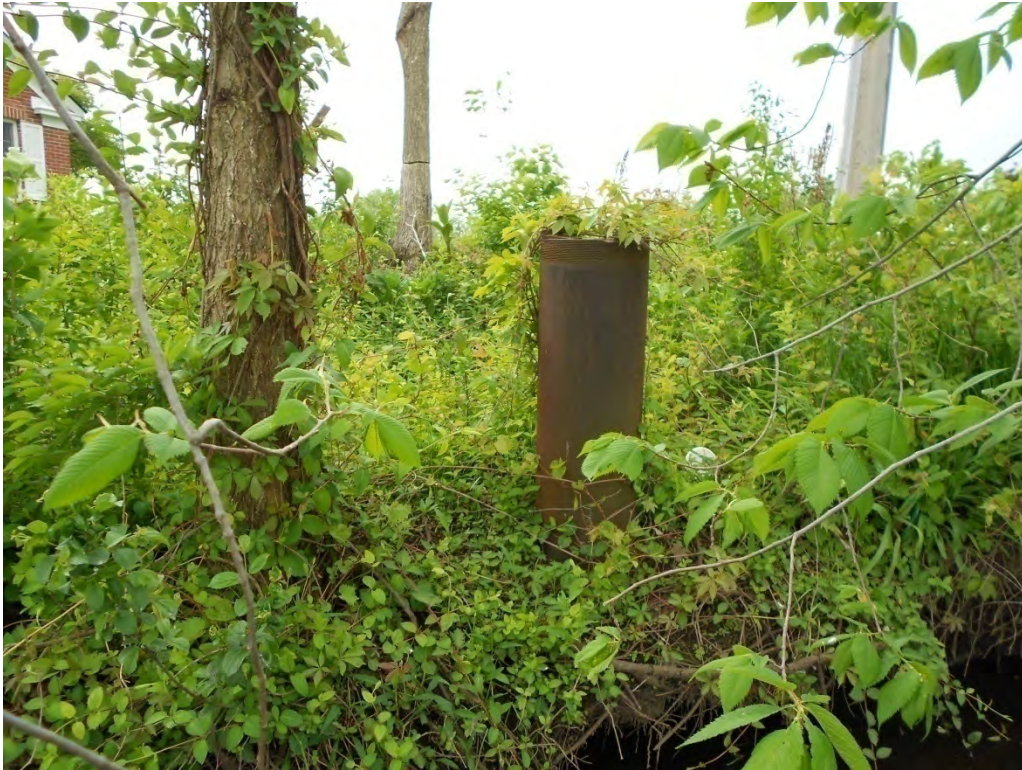
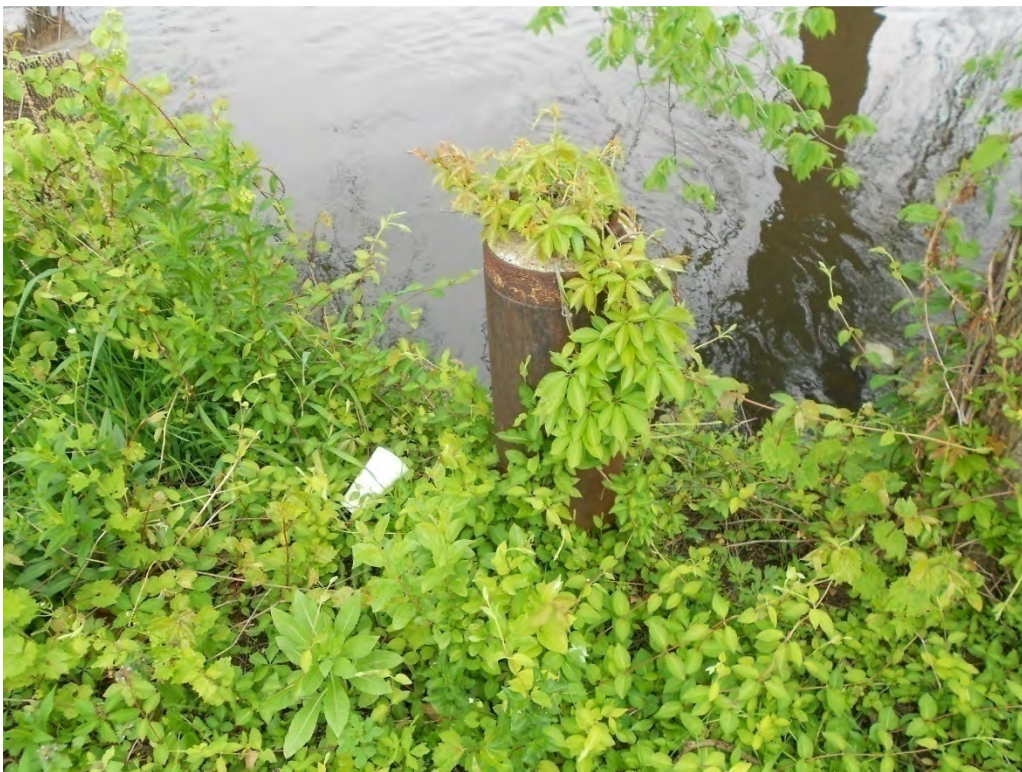
View of west bollard from channel

View of west bollard from bank

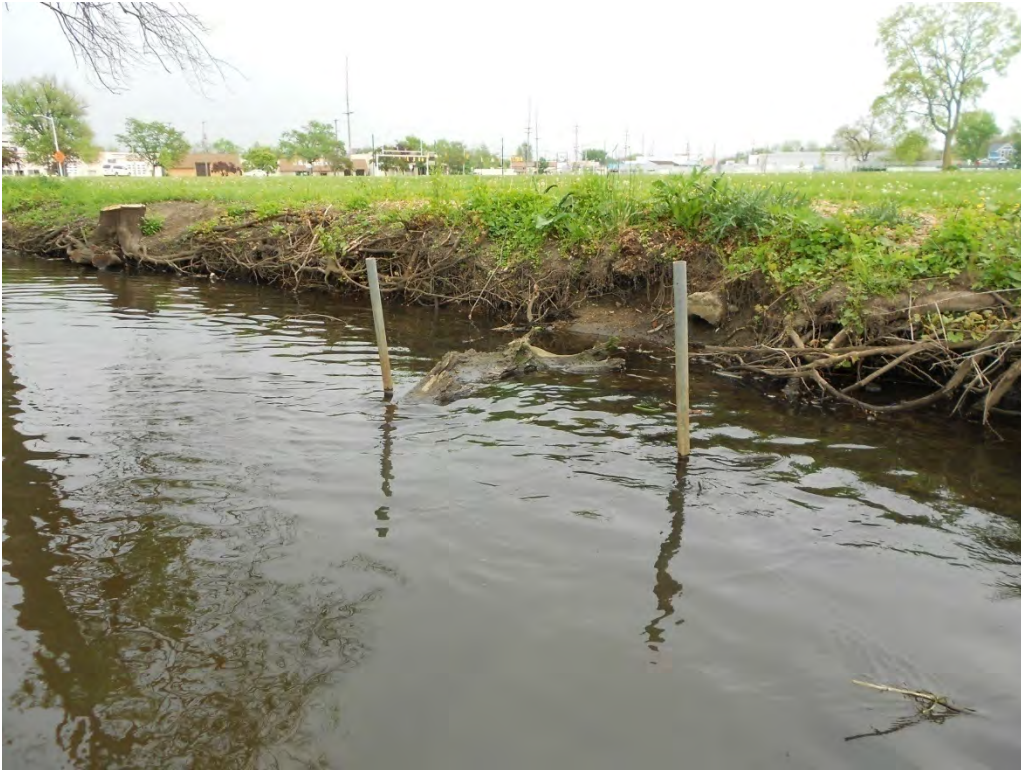
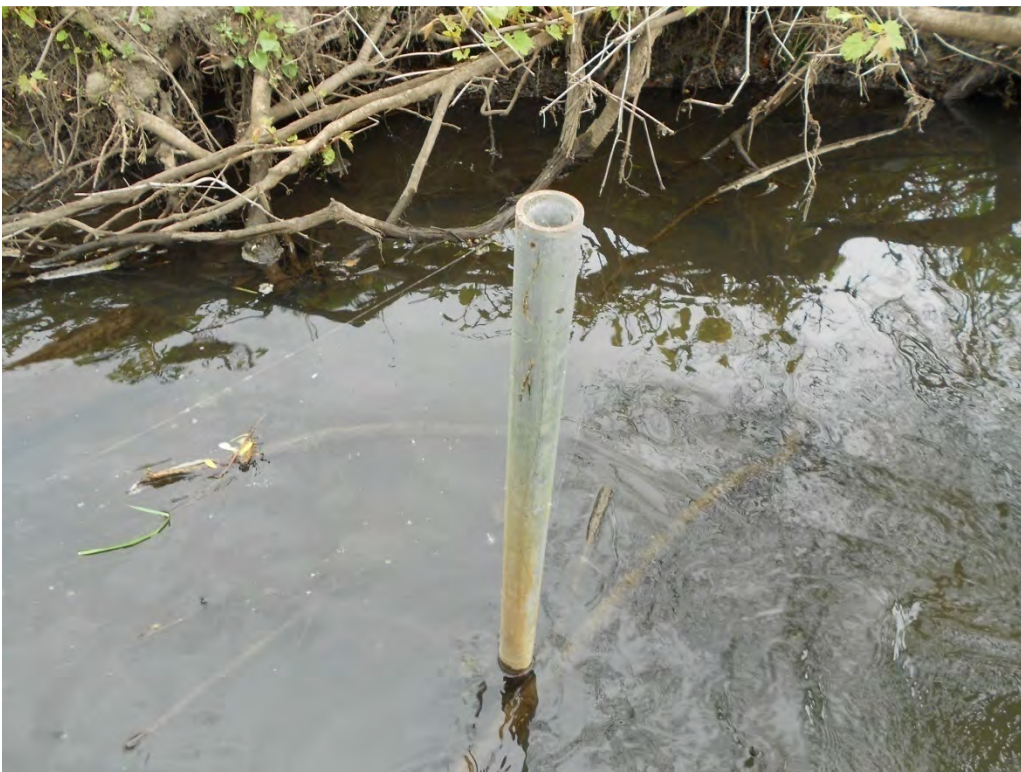
- There appears to be additional pier debris in the channel around the pipes.
- The steel pipes are leaning slightly and have signs of early corrosion near the waterline.

View of the structure from the upstream channel

Close-up of steel pipe

- Remove the pipes and other pier debris in conjunction with excavation work.

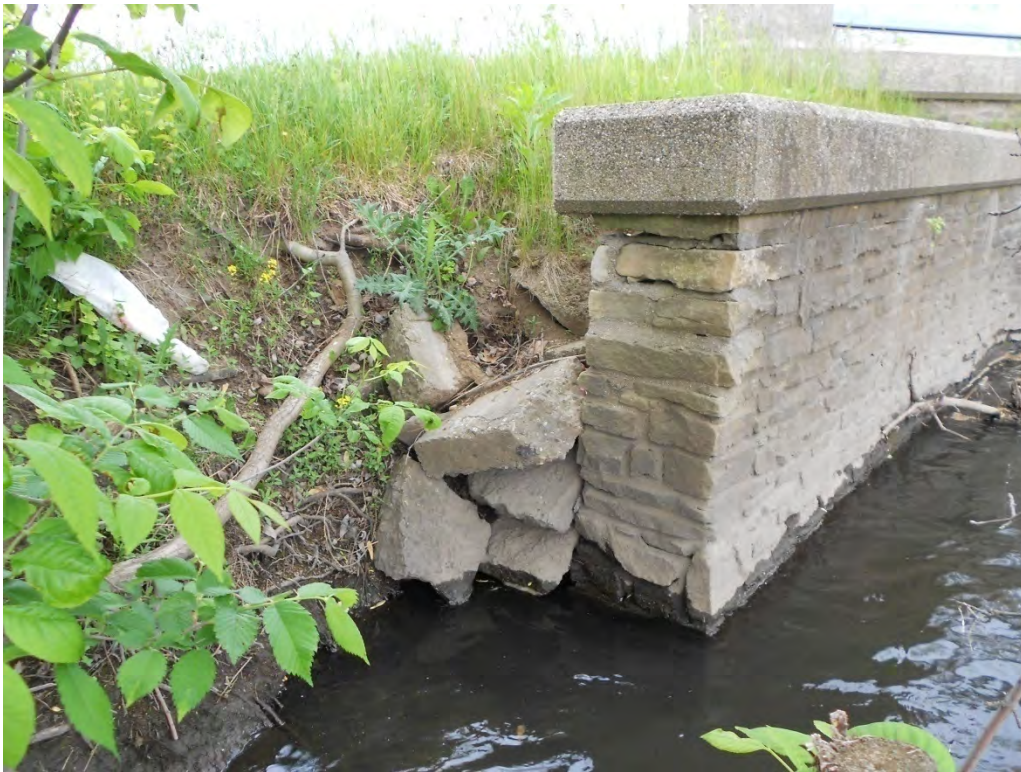
- Moderate erosion was noted behind the southwest wingwall with concrete rubble placed as riprap. Cracking and gaps were noted in the mortar joints.
- There is a significant amount of woody debris caught on the upstream face of the structure. The debris is reducing the flow in the west pipe, causing high velocities and deepened channel in the east pipe.

Bank erosion around southwest wingwall with concrete rubble riprap

- The wingwalls and headwalls are masonry-type construction with various degrees of cracking and are more susceptible to damage from vibration than concrete. Therefore it is recommended that the cofferdams at the Crosstown Parkway bridge be constructed of sand bag walls, placed with approximately 4' clearance from the walls.
- The unidentified steel cover in the northwest should be excavated and opened prior to cofferdam installation to check for a possible utility crossing.

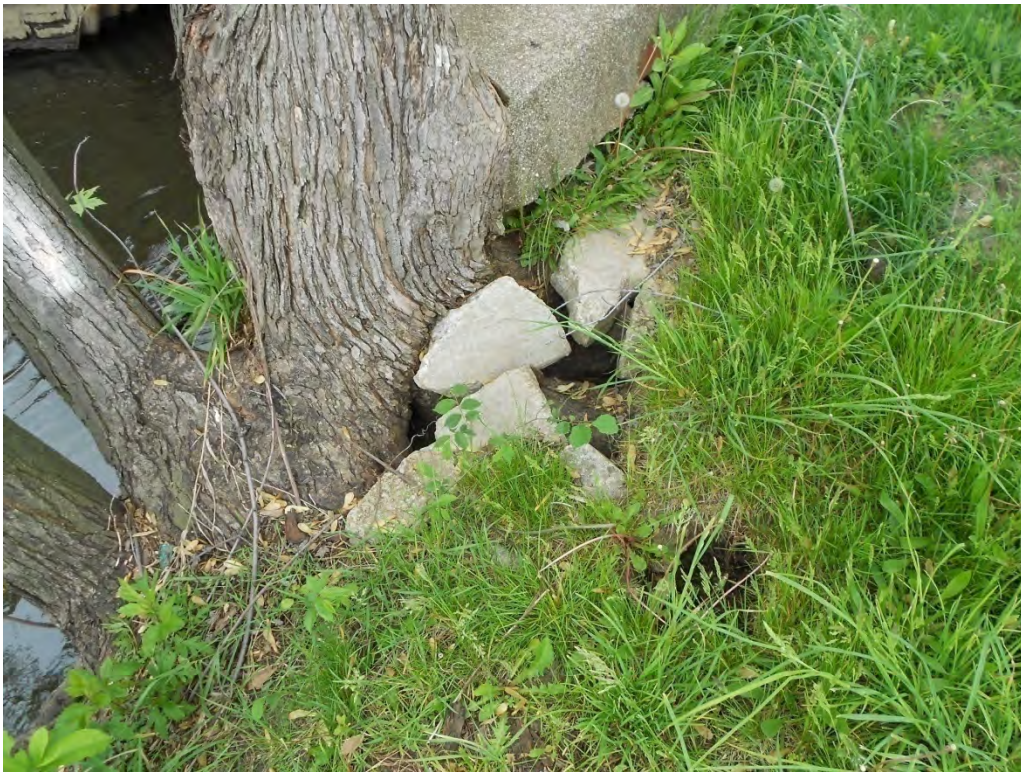
- Minor surface corrosion was noted on the culverts above the waterline and moderate to severe corrosion with scaling at the waterline.
- There is a large tree growing at the end of the southeast wingwall. The southeast wingwall has minor gaps and cracks in the mortar joints. There is a large sinkhole behind the wall filled with concrete rubble.

Sink hole filled with concrete rubble behind southeast wingwall

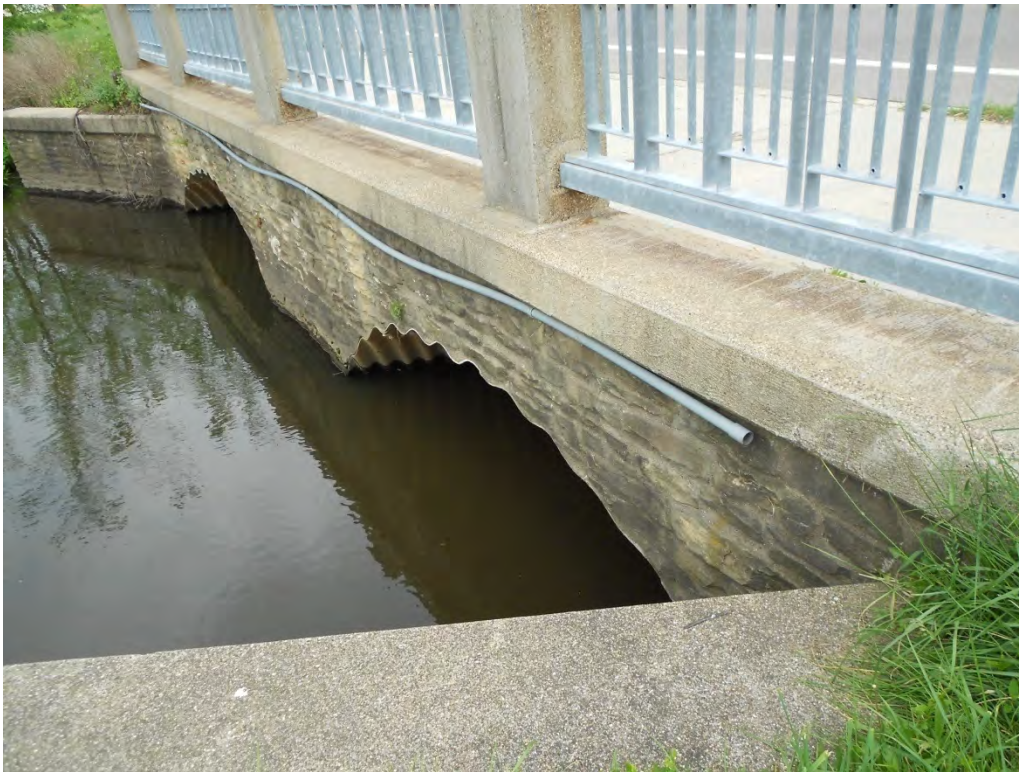
- There is an unidentified steel cover in the northwest and an abandoned conduit on the north headwall.
- Severe erosion was noted around the northwest wingwall with failed concrete rubble placed as riprap. Minor gaps and cracks were noted in the mortar joints.

Abandoned conduit on north headwall

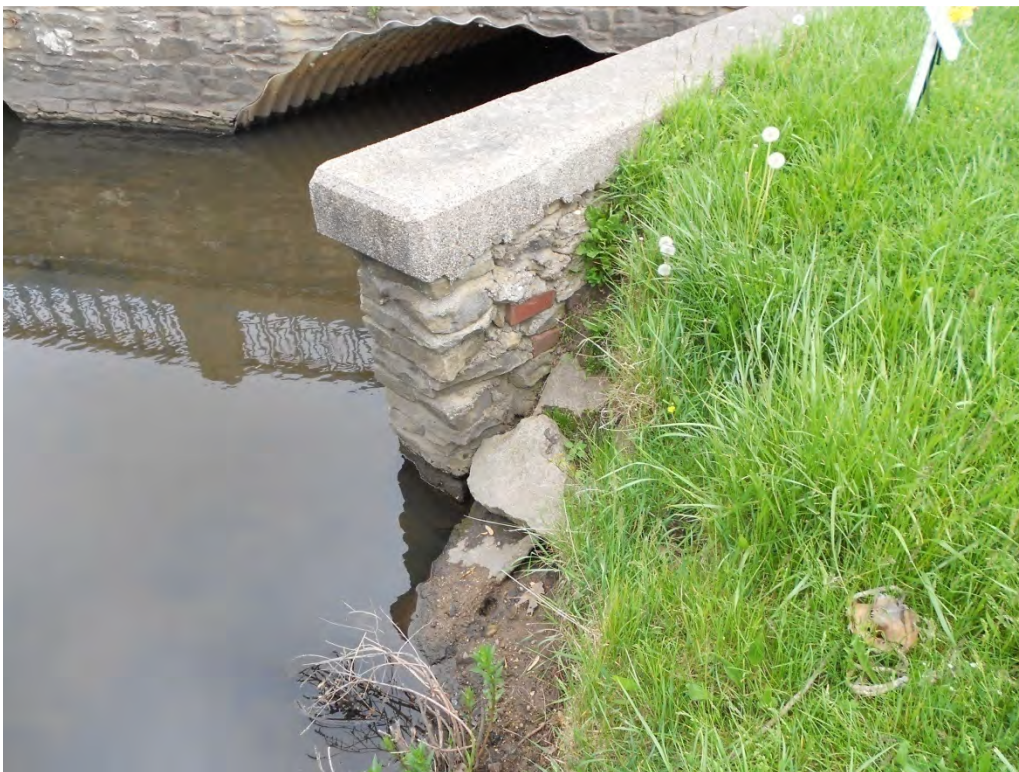
Bank erosion around northwest wingwall

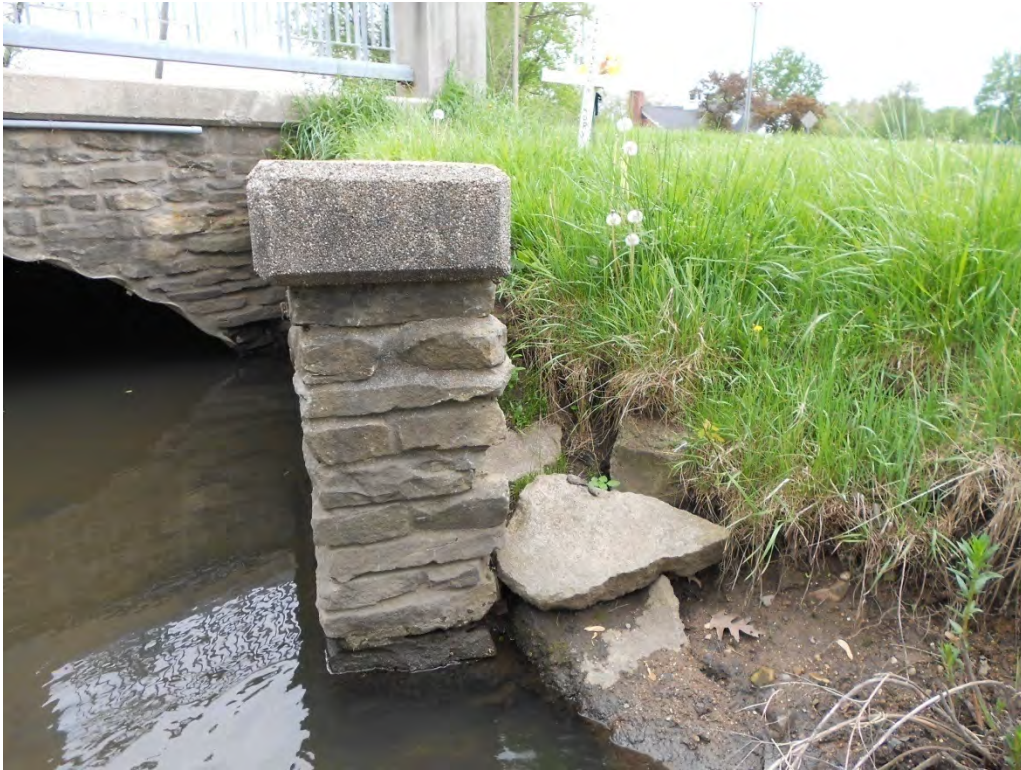
Bank erosion around northwest wingwall with concrete rubble riprap

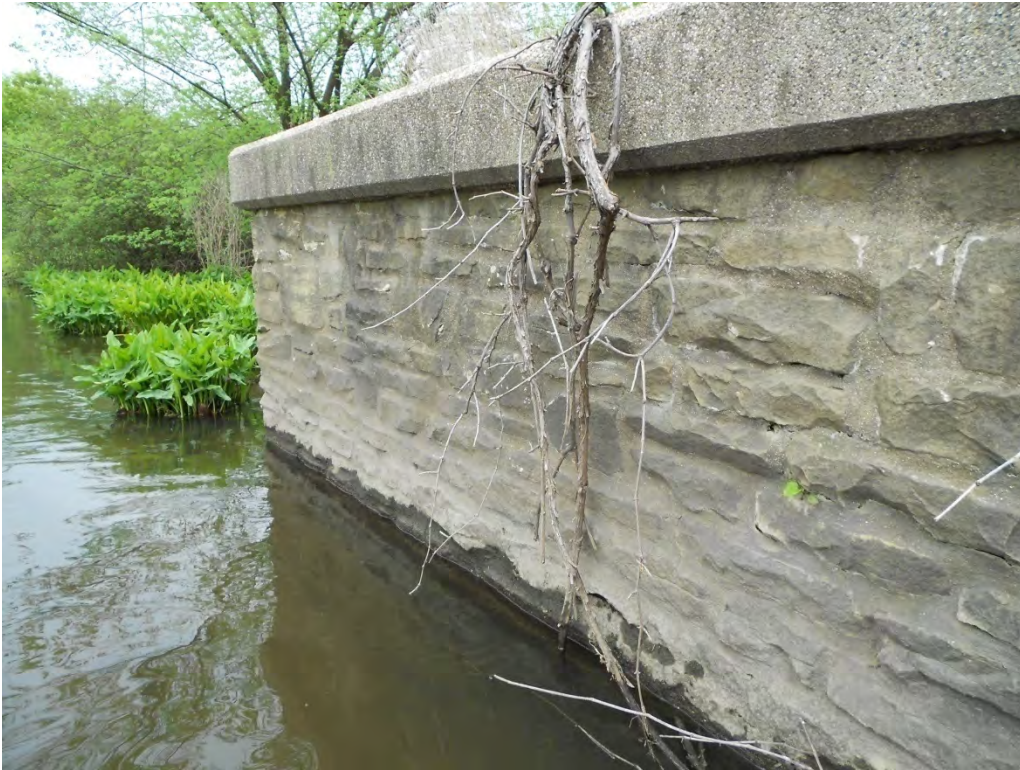
- The channel has deepened in the northeast however no footing was detected.
- Minor gaps and cracks were noted in the northeast wingwall mortar joints. The wall is overgrown with vines. Moderate erosion was noted behind the wall.

Vine growth on northeast wingwall
